INSIDE REPAIRS

ROOF INFORMATION

HUGE STORM APRIL 23, 2003 IN PEORIA

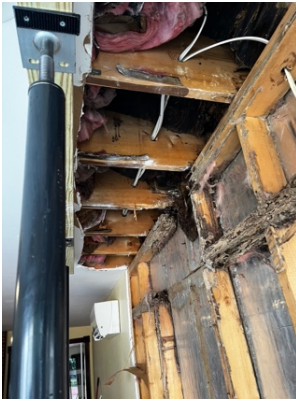
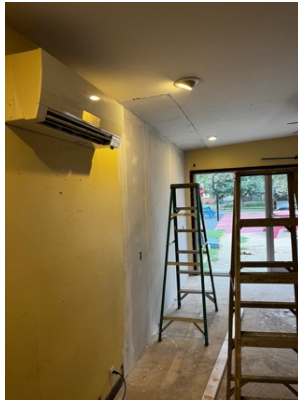
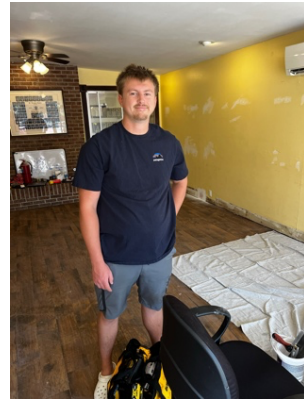
This time the basement was spared toilet backing up with Peoria's problems. But the Founder's Room was a waterfall damaging ceiling, wall, and particle backed flooring.

Insurance company inspected and did not cover insides (found indications of long-term leak in the wall but not showing) and roof not damaged by hail or wind.

Before fixing the Founder's Room interior, River City completed a temporary patching on the suspect leak problems, and we sealed up the outside fascia.
