INSIDE REPAIRS

ROOF INFORMATION

HUGE STORM APRIL 23, 2003 IN PEORIA

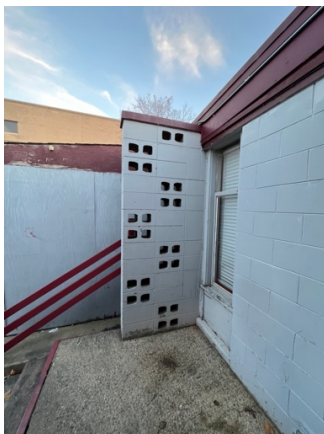
One major change, the "climbing" wall outside the Kitchen door is being removed. Of course, a ladder can be used to access the roof, but that takes work and knowledge as compared to just climbing a wall with holes. It goes the way of the metal fireplace. Time flies.
